Troubleshooting Overview

This flyer outlines the major reasons of site performance issues and helps you to install a site as efficiently, safely and economically as possible.

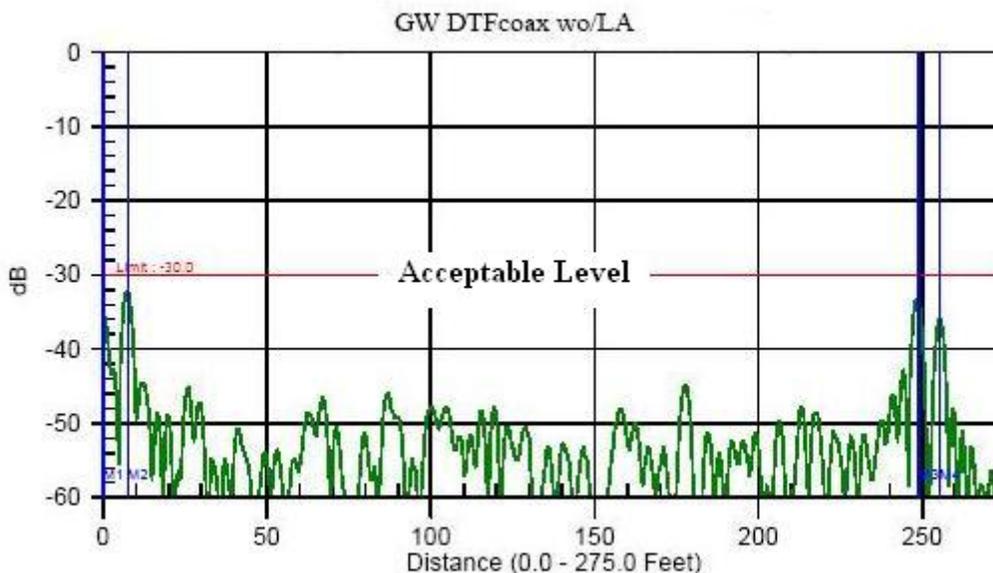
Typical AirCell® Distance to Fault Result-dB Level

Unique AirCell® Dielectric design has wider variation, reflecting fully-hermetically sealed, fully-bonded discs.

- ⇒ A distance to fault spike is mostly commonly caused by damaged cable, improperly installed connector or test equipment problems.
